Project Update

Summer 2024/25

Managing Stockton's Coastline

Stockton Coastline Works

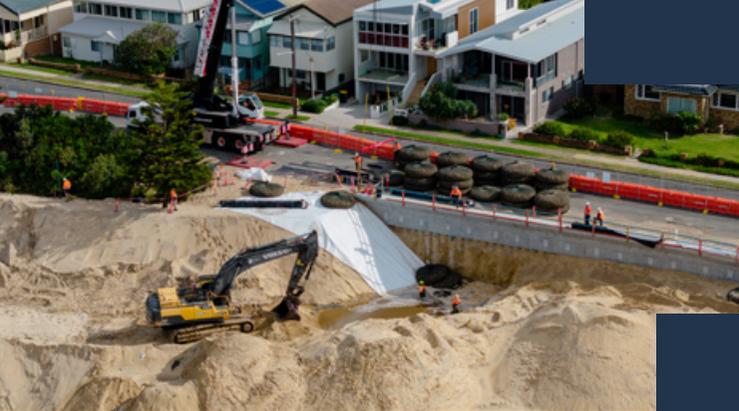
Mitchell Street works. Image supplied by Brefni.

Work on the Mitchell Street protection structures, a new sea wall and rock bag structure, was recently completed. This project was co-funded by the NSW Government via a grant from the Coastal and Estuary Grants Program. We're working to relocate and repurpose the WWII tank traps that were unearthed during construction of these protection structures. Looking ahead, we will continue our delivery of protection structures.

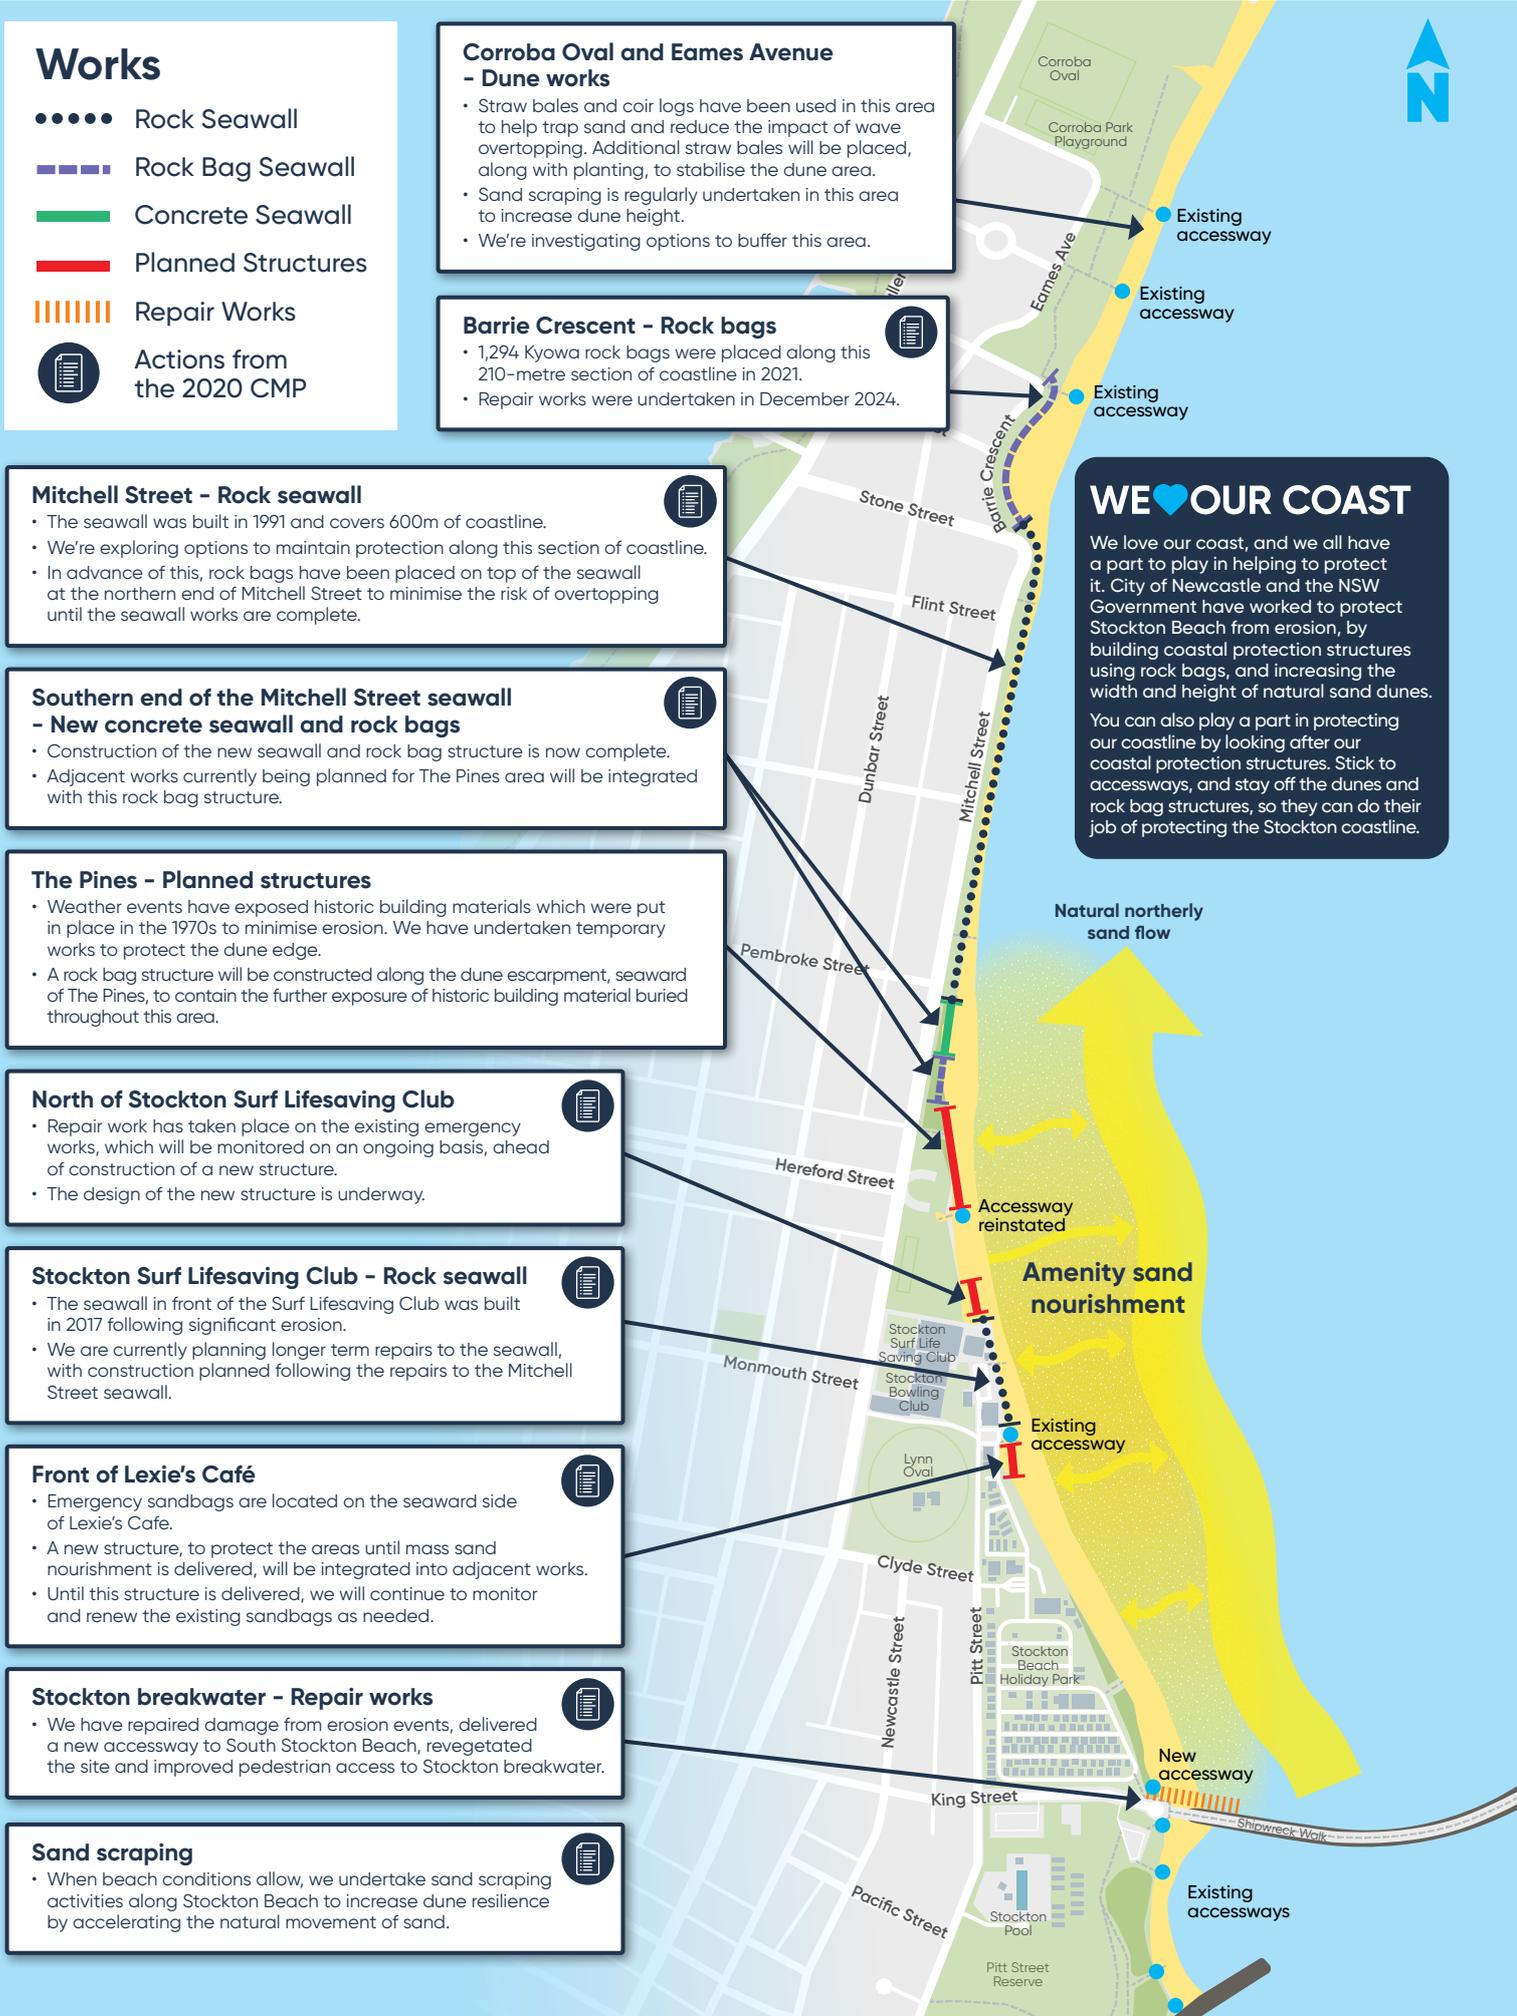
- Rock Seawall
- ▬▬▬▬ Rock Bag Seawall
- ▬▬▬▬ Concrete Seawall
- ▬▬▬▬ Planned Structures
- ▬▬▬▬ Repair Works
- Actions from the 2020 CMP

- Straw bales and coir logs have been used in this area to help trap sand and reduce the impact of wave overtopping. Additional straw bales will be placed, along with planting, to stabilise the dune area.
- Sand scraping is regularly undertaken in this area to increase dune height.
- We're investigating options to buffer this area.

- 1,294 Kyowa rock bags were placed along this 210-metre section of coastline in 2021.
- Repair works were undertaken in December 2024.

- The seawall was built in 1991 and covers 600m of coastline.
- We're exploring options to maintain protection along this section of coastline.
- In advance of this, rock bags have been placed on top of the seawall at the northern end of Mitchell Street to minimise the risk of overtopping until the seawall works are complete.

- Construction of the new seawall and rock bag structure is now complete.
- Adjacent works currently being planned for The Pines area will be integrated with this rock bag structure.

- Weather events have exposed historic building materials which were put in place in the 1970s to minimise erosion. We have undertaken temporary works to protect the dune edge.
- A rock bag structure will be constructed along the dune escarpment, seaward of The Pines, to contain the further exposure of historic building material buried throughout this area.

- Repair work has taken place on the existing emergency works, which will be monitored on an ongoing basis, ahead of construction of a new structure.
- The design of the new structure is underway.

- The seawall in front of the Surf Lifesaving Club was built in 2017 following significant erosion.
- We are currently planning longer term repairs to the seawall, with construction planned following the repairs to the Mitchell Street seawall.

- Emergency sandbags are located on the seaward side of Lexie's Cafe.
- A new structure, to protect the areas until mass sand nourishment is delivered, will be integrated into adjacent works.
- Until this structure is delivered, we will continue to monitor and renew the existing sandbags as needed.

- We have repaired damage from erosion events, delivered a new accessway to South Stockton Beach, revegetated the site and improved pedestrian access to Stockton breakwater.
